Manhole Inspection Summary

Manhole # S2100_006MH

Insp Date: **10/9/08 9:04 AM**

Location Address: **N. FULTON AV**

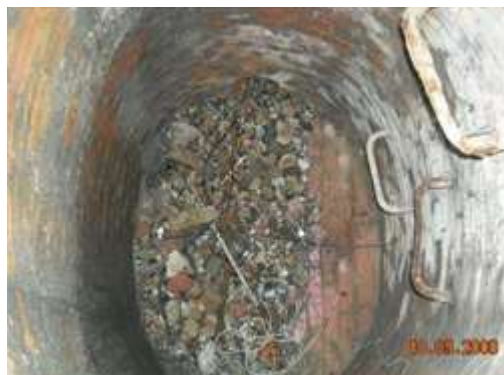
Top View

Channel Material: **Brick** ☐ Parged ☒ **Debris** (not Condition related)

Steps Count: **3** Missing: **0** ☒ **Corroded**

Corroded steps. Channel debris.

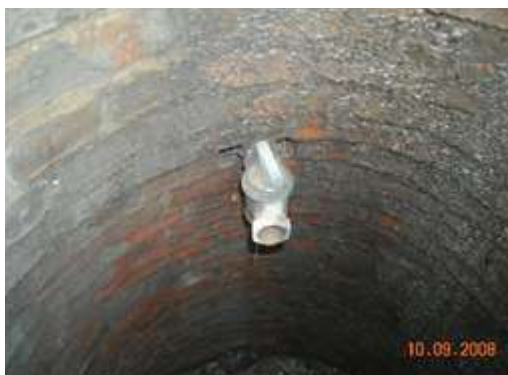
MH Valve

Condition: ☐ Sound ☐ Cracked ☒ **Root Intrusion** ☐ Loose Brick ☐ Deteriorated

Infiltration: ☐ None ☐ Joint ☐ Cracks ☒ **Mortar** ☒ **Roots** ☒ **Wall**

Barrel root intrusion and infiltration.

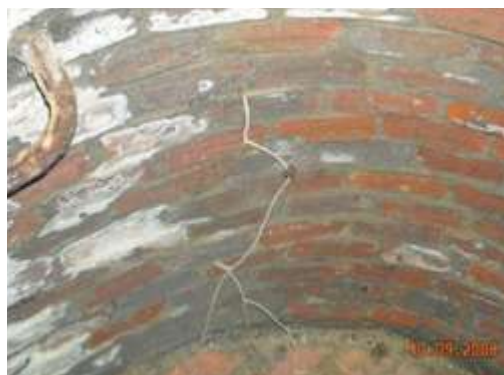
Defect

Infiltration: ☐ None ☐ Joint ☐ Cracks ☒ **Mortar** ☐ Roots ☒ **Wall**

Corbel and Barrel infiltration.

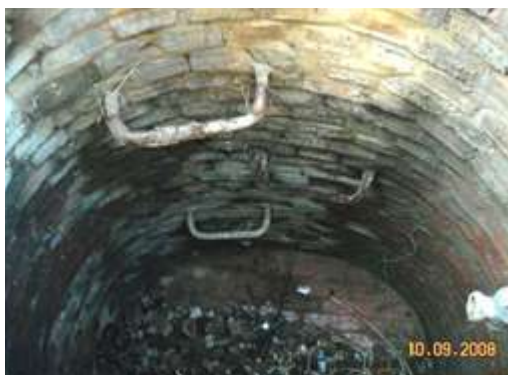
Defect

Frame Offset: **0** (in.) Condition: ☐ Sound ☐ Cracked ☒ **Leaks**

Condition: ☐ Sound ☐ Cracked ☐ Root Intrusion ☐ Loose Brick ☒ **Deteriorated**

Infiltration: ☐ None ☒ **Joint** ☐ Cracks ☐ Mortar ☐ Roots ☐ Wall

Frame leaks. Adjustment deterioration and infiltration.

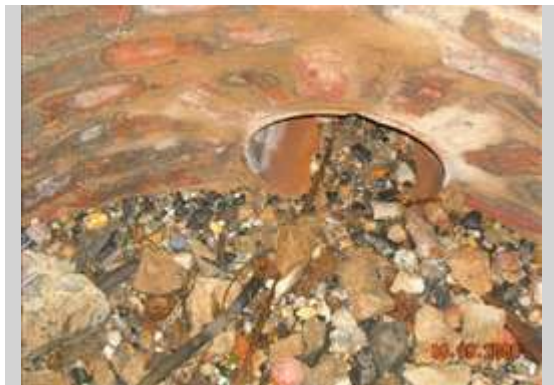
8 in. Circular Gravity Sewer

Deposits: ☐ None ☒ **Mud** ☐ Sludge ☒ **Debris** ☐ Grease

Silt Depth: **2** (in.)

Deposits Extent: **Light**
